## Appendix E: Sensitivity Study

## Appendix G: Empirical-based fragility curves

## Appendix K: Wall geometries from BAG 3D

# IEDB: Opscho nen contou rlijnen

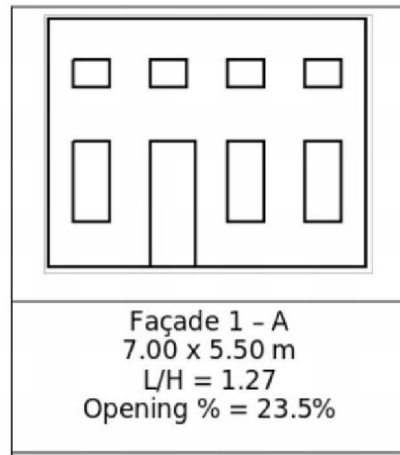
Figure E1. Façade 1, geometry A employed for the sensitivity study.

In addition to the main framework, a sensitivity study is conducted to evaluate the influence of the different parameters and modelling choices on the response of façade to settlement actions. The investigation refers to Façade 1, geometry variation A, placed on soil A, with standard masonry material, subjected to asymmetric hogging settlement (knick point at L/3) and soil-structure interaction stiffness based on Gazetas [26][31] (Figure E1). From this base model, one parameter at the time is varied and analysed. The following parameters are varied:

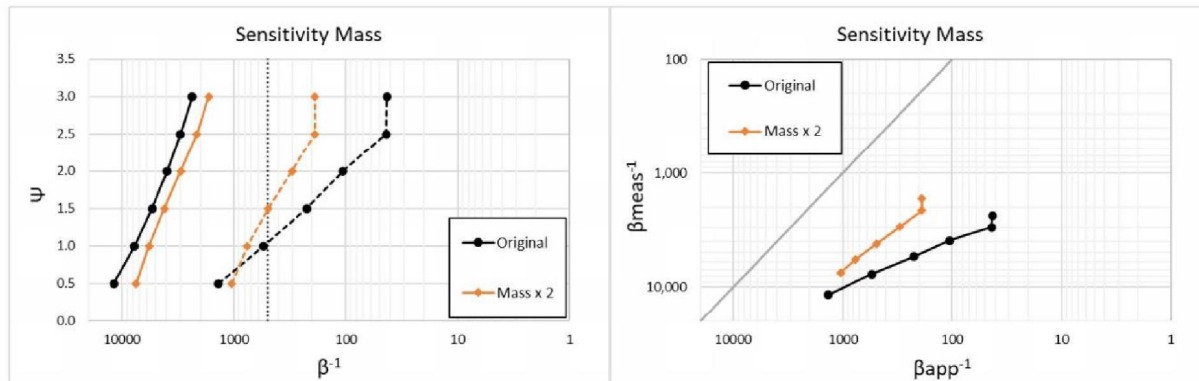
- Façade mass: the original model and one with double façade mass are compared. The increment in mass does not lead to additional vulnerability. On the contrary, it shows a positive effect in terms of both measured and applied angular distortion. The plots are shown in Figure E3.

Figure E3. Sensitivity study on model mass. Dashed lines refers to applied  $\beta^{-1}$ .

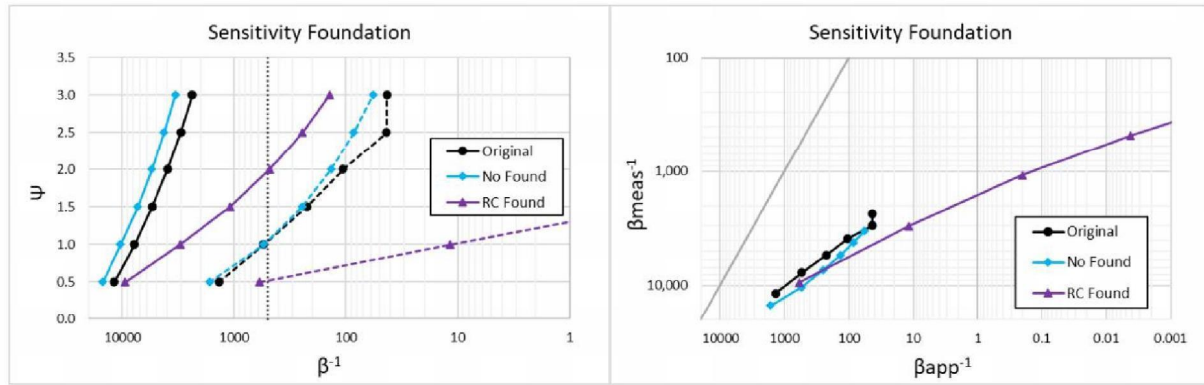
- Foundation type: in addition to the unreinforced masonry foundation, two variations where reinforced concrete foundation and no foundation are analysed. The difference between unreinforced and reinforced foundation is pretty large. The concrete strip largely improves the performance of the façade in terms of measured and applied angular distortion. The latter tends to a pretty large value to reach severe light damage. For this type of façade, the modelling of the unreinforced foundation has small effects on the final response of the façade to settlement. The  $\beta$ - $\Psi$  plot is shown in Figure E4.

Figure E4. Sensitivity study on foundation type. Dashed lines refers to applied  $\beta^{-1}$ .

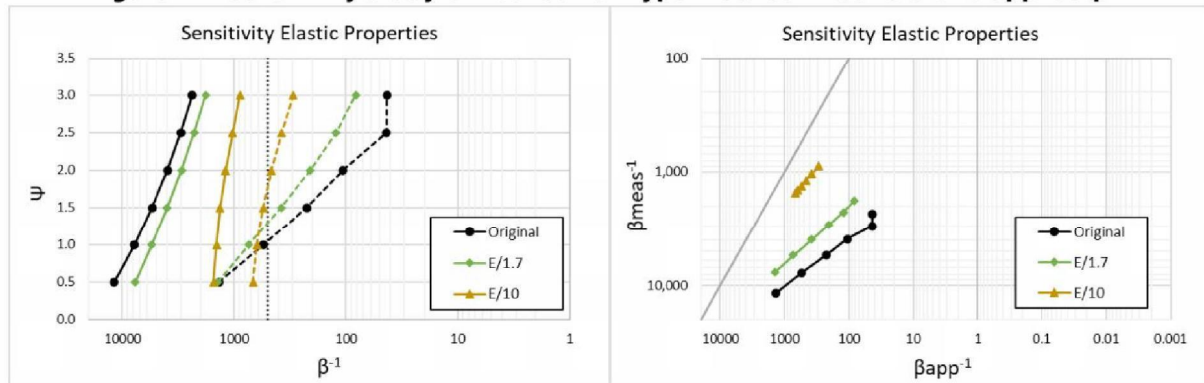
- Façade stiffness: the effect of the façade stiffness on the settlement response is shown in Figure E5. In addition to the original stiffness (5 GPa), two variations

with reduced stiffness are considered. The reason of a reduced stiffness lays on the long term effects of the masonry material, also known as viscous-elasticity or creep-relaxation. This is based to the fact that the strain history affects the actual stress situation. This aspect is treated in the Eurocode 6 [35]. Equation 3.8 of the code provides a formulation for the long term stiffness, in order to allow creep effects. The stiffness is equal to the original stiffness divided by a creep factor (+1) depending on the material. For clay masonry the factor is equal to 0.7. The long term stiffness is then equal to 5 GPa divided by 1.7, which is equal to about 2.94 GPa. As additional variation, a value of 0.5 GPa is employed in order to consider a flexible, pre-damaged façade. The results clearly show the positive effects given by the reduced stiffness, which increase the measured angular distortion to damage the façade. On the other hand, the applied settlement to reach this damage is lower since the large flexibility allows the façade to reach a larger measured  $\beta$  earlier.

Figure E5. Sensitivity study on elastic properties. Dashed lines refers to applied  $\beta^{-1}$ .

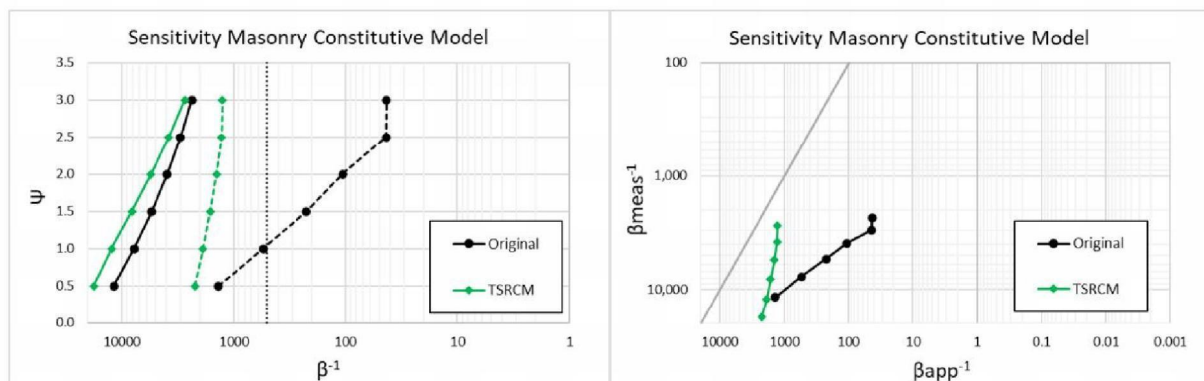
- Constitutive model: in addition to the orthotropic Engineering Masonry Model (EMM), the isotropic Total Strain Rotating Crack Model (TSRCM) is investigated. As already explained and shown in Appendix B, the TSRCM is quite vulnerable with respect to the EMM. This one has pre-defined direction (4: horizontal, vertical and two diagonal) for the cracks and each resistance is computed following different formulation which account for different strength. The TSRCM evaluates the cracking perpendicular to the principal stress directions. This cause a premature cracking and especially to an overestimation of the vertical cracking, which is treated quite differently with respect to the EMM (see Appendix B). The comparison between the two models in terms of  $\beta$ - $\Psi$  is shown in Figure E7.

Figure E7. Sensitivity study on masonry constitutive model. Dashed lines refers to applied  $\beta^{-1}$ .

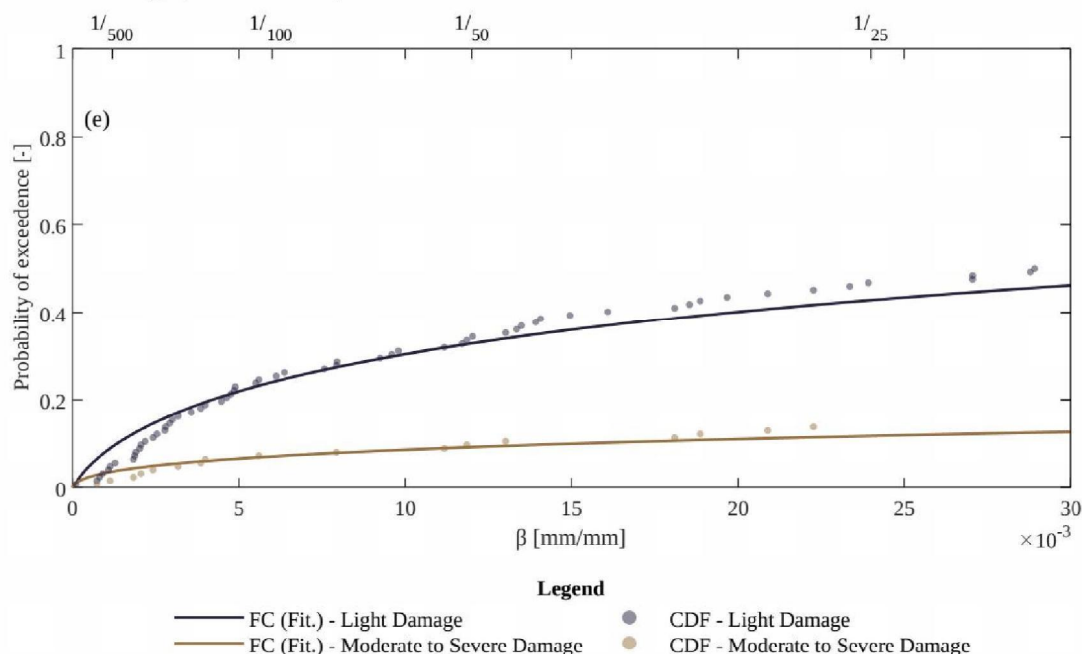
**Figure G1. Fragility curves generated for the relative rotation  $\beta$  for building resting on shallow foundations.**

The cumulative density functions are obtained by counting the number of buildings reaching or exceeding each damage state (i.e., “light damage” and “moderate to severe damage”), in relation to the total number of cases. The fragility curves were then derived by fitting a lognormal distribution to the cumulative density functions.

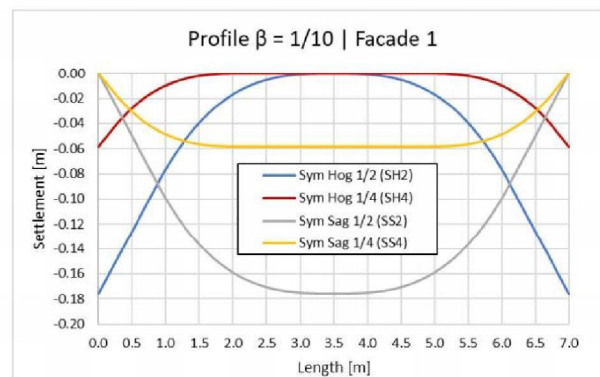
In the main report, four settlement profiles are selected, two symmetric and two asymmetric profiles with different knick points. The employed settlement profiles are all hogging profiles. This choice follows field data (see Appendix G), which shows that hogging profiles are the most common ones found in the inspected cases. A sensitivity study where two sagging settlement profiles are modelled underneath four façades (Façade 1, 2, 3 and 4) is herein conducted. The two sagging profiles are produced by flipping the two hogging settlements. The four settlement profiles (calibrated on Façade 1) are shown in Figure H1. This sensitivity study is in addition to the existing parameters varied in Appendix E and warrants a separate discussion.

**Figure H1. Hogging and Sagging settlement profiles applied to the model of Façade 1.**

The results in terms of  $\beta$ - $\Psi$  of Façade 1 subjected to the four types of settlement are reported in Figure H2. The data points are also plotted in a graph where applied and measured angular distortions are compared (Figure H2). The curves show that the angular distortion measured at the base of the façade for all damage points is lower for the two hogging cases. On the contrary, the façade gets damaged for reduced values of applied settlement. The ratio between measured and applied angular distortion reduces as well. This additional vulnerability is strictly correlated to the façade geometry. When the middle portion sags, the top bed-joint of the pier between door and window opens up (Figure H3). Additional flexural cracks in the more flexible central part of the façade also appear pretty early in the settlement stage. Moreover, the portion of façade mobilized by the sagging action is much higher than the corresponding hogging settlement (Figure H1).

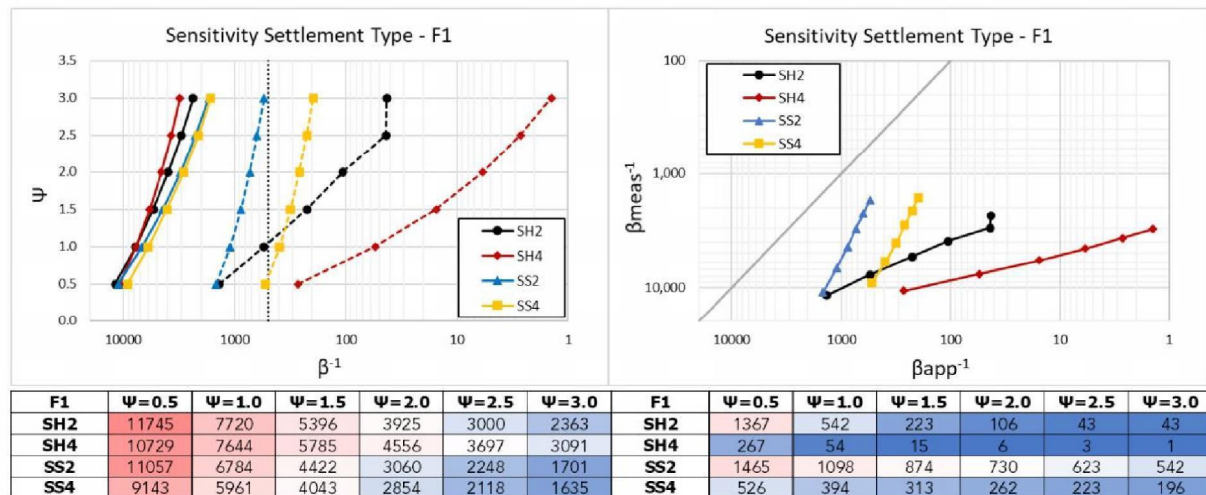
Figure H2. Sensitivity study on settlement profiles for Façade 1. Dashed lines refers to applied  $\beta$ . Measured (left) and applied (right)  $\beta^{-1}$  values.

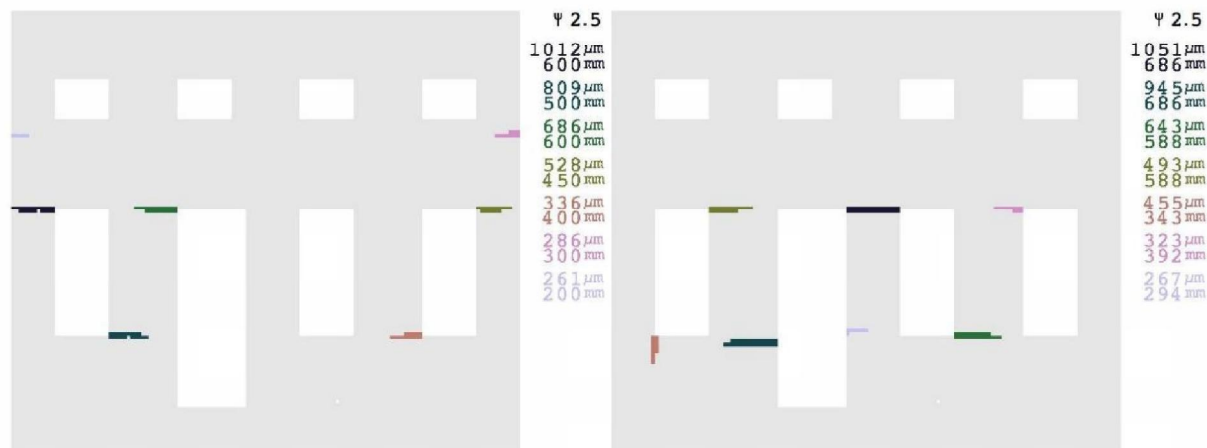
Figure H3. Crack pattern of Façade 1, subjected to hogging SH2 (left) and sagging SS4 (right). Cracks at DS2.

In conclusion, most façades are more vulnerable to hogging settlement actions in terms of both measured and applied settlement. Only Façade 1, due to its large opening area in the middle of the façade, shows damage for lower sagging settlement amplitude with respect to the hogging settlement. This is mainly correlated with the geometry of the façade and to the fact that the imposed sagging actions deform a larger portion of the façade. Due to the limited observation of these settlement profiles in the field (Appendix G) the hogging settlement is still considered the best option to characterize the behaviour of masonry façades to vertical base deformation and represents a conservative variation when selecting only one type of settlement profile.

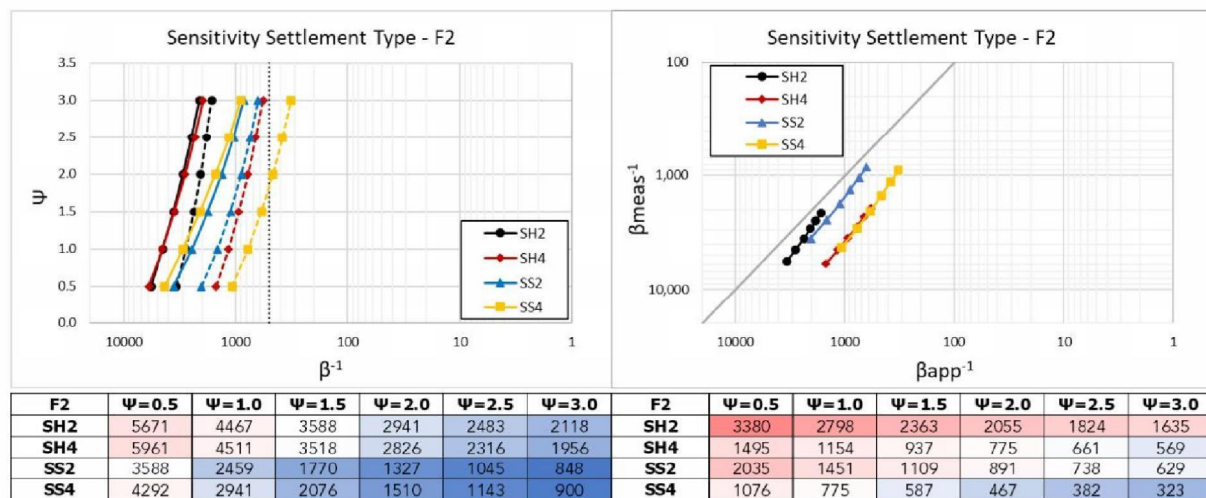
When analysing the results of the long Façade 2, it can be seen how the failure mechanism shifts from a brittle vertical cracking starting from the top of the façade to a flexural mechanism involving the piers at the right side of the façade (Figure H5). The top part of the façade when sagging is applied is entirely in compression. The tension part now shifts to the stiffer foundation which is able to better adapt to the deformation without showing brittle vertical cracking. The plots in Figure H4 show that the hogging settlement is still the most critical for Façade 2. Both applied and measured settlement at certain damage is still the lowest for hogging settlement (SH2). The measured-applied  $\beta$  ratio of SH2 and SS2 is pretty similar.

**Figure H4. Sensitivity study on settlement profiles for Façade 2. Dashed lines refers to applied  $\beta$ . Measured (left) and applied (right)  $\beta^{-1}$  values.**

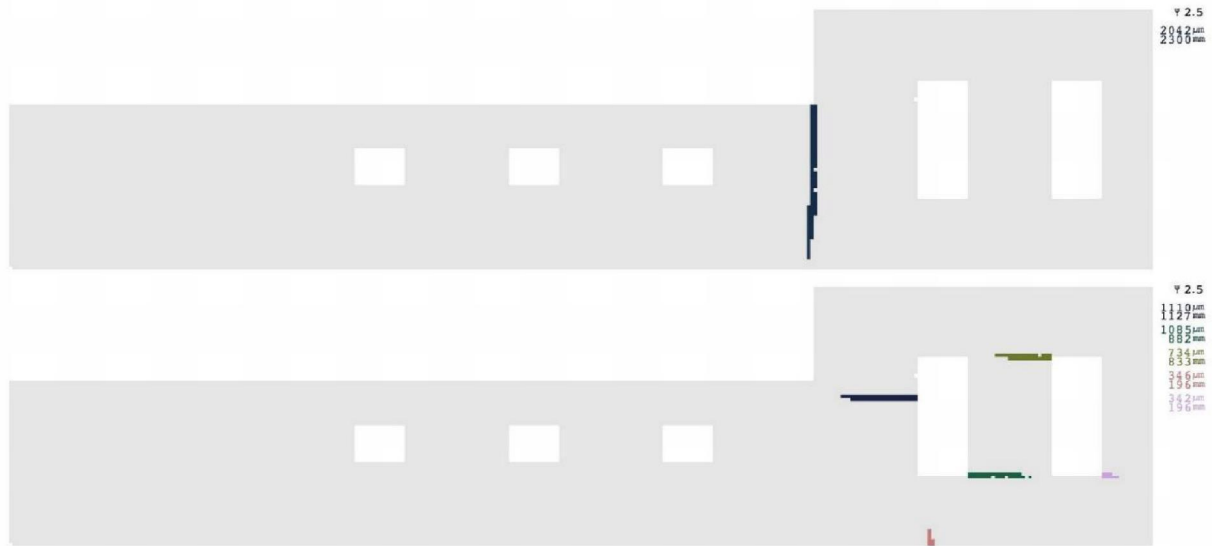
Figure H5. Crack pattern of Façade 2, subjected to hogging SH2 (left) and sagging SS4 (right). Cracks at DS2.

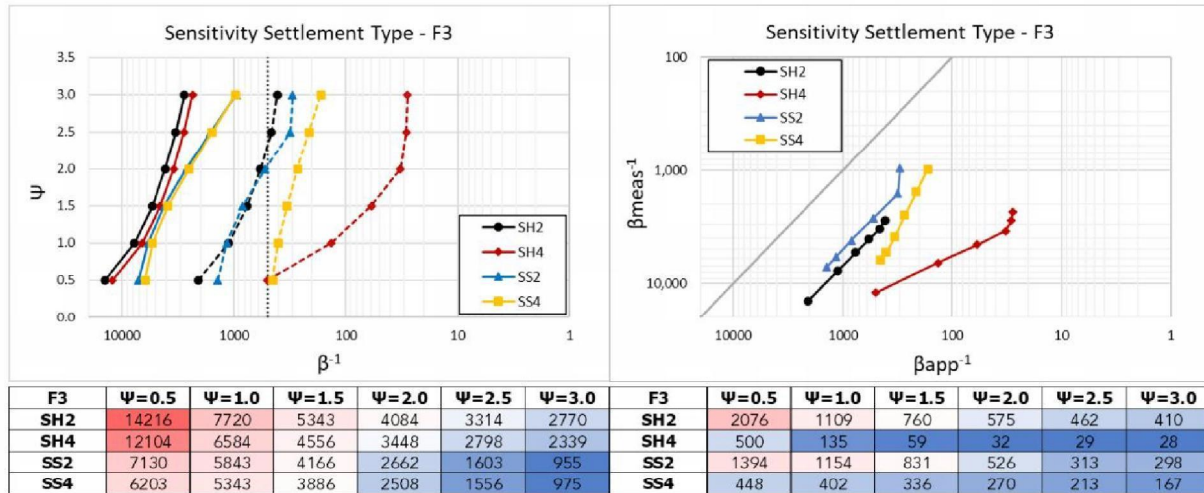
A similar shift in the failure mechanism is also detected in Façade 3. Here the vertical cracks below the window, typically found during hogging settlement, are replaced by horizontal flexural cracks starting at window corners (Figure H7). Damage is mainly located at ground floor in the central pier. Plots of  $\beta$ - $\Psi$

are shown in Figure H6. The two models with hogging settlement are still the most critical in terms of measured and applied angular distortion.

Figure H6. Sensitivity study on settlement profiles for Façade 3. Dashed lines refers to applied  $\beta$ . Measured (left) and applied (right)  $\beta^{-1}$  values.

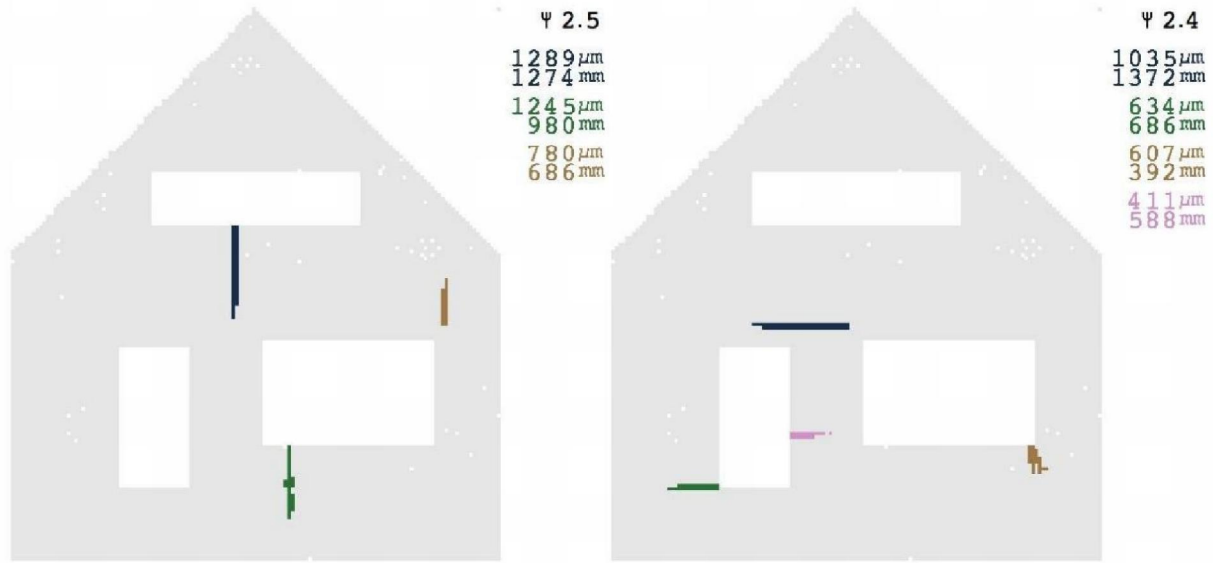
Figure H7. Crack pattern of Façade 3, subjected to hogging SH2 (left) and sagging SS4 (right). Cracks at DS2.

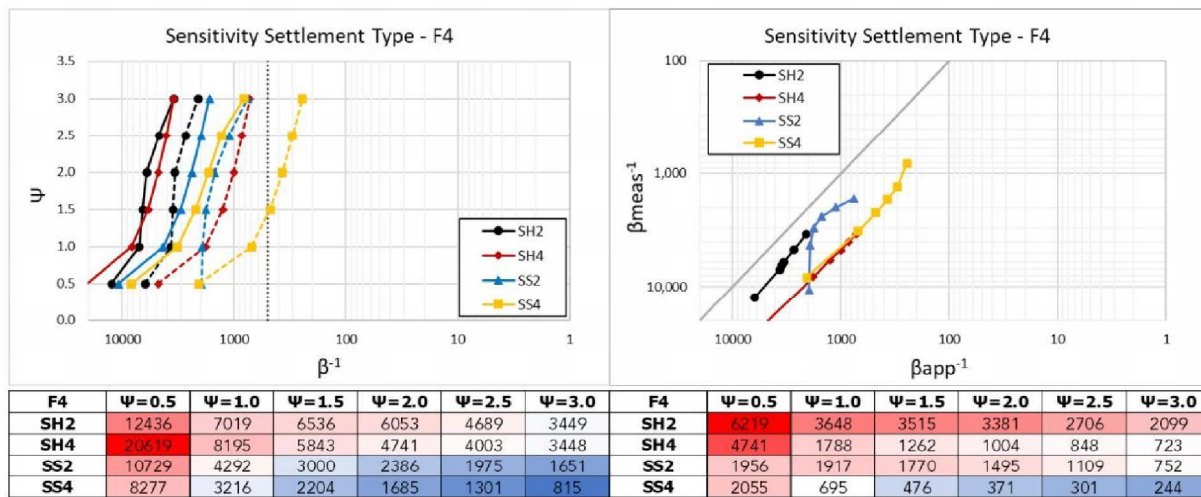
Façade 4 results are summarized in Figure H8. The crack pattern due to hogging and sagging settlement actions is depicted in Figure H9. The failure when hogging deformations are applied is concentrated at the top of the façade, where vertical cracking extends from the top edge to the window corner due to limited spandrel height. Masonry spandrels result in compression when sagging actions are applied. In this case, diagonal shear cracks in the window banks are detected at the two lateral sides of the façade. An horizontal flexural crack is also detected at the top of the left pier of the mid window. Similar to the other long façade (Façade 2), Façade 4 presents more vulnerability to hogging actions rather than sagging actions.

Figure H8. Sensitivity study on settlement profiles for Façade 4. Dashed lines refers to applied  $\beta$ . Measured (left) and applied (right)  $\beta^{-1}$  values.

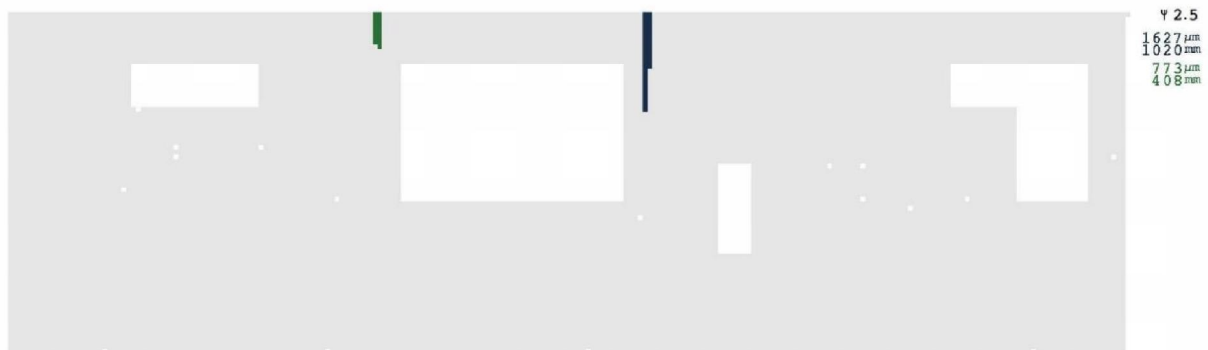
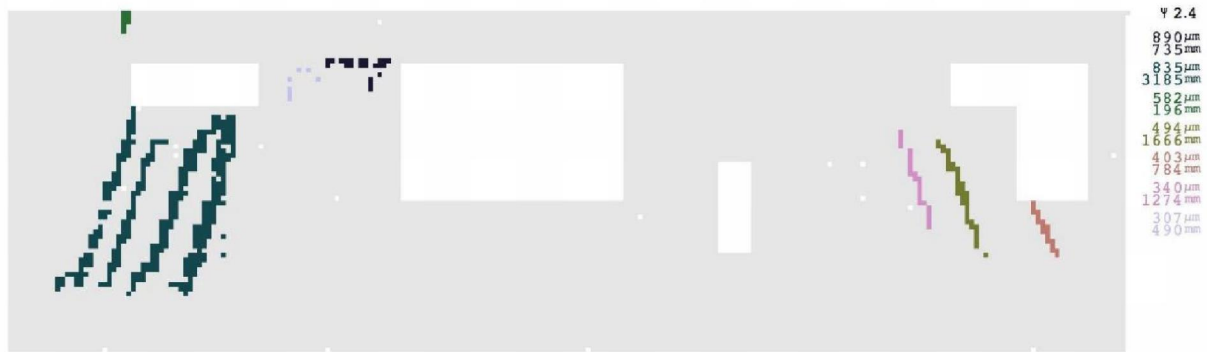
Figure H9. Crack pattern of Façade 4, subjected to hogging SH2 (left) and sagging SS4 (right). Cracks at DS2.

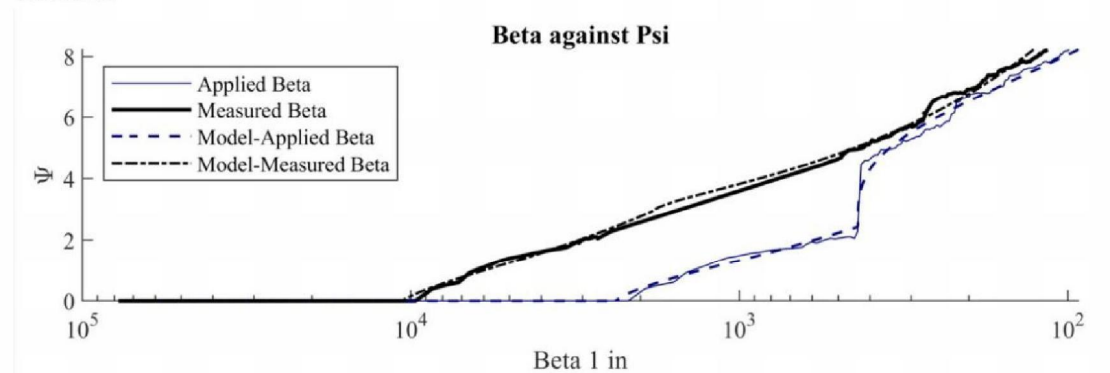
Several of the FEM models did not reach high values of Psi and several other models exhibited small jumps in Psi when the applied beta was smoothly increased due to the cracking behaviour and the solving algorithms employed in the (material) models. These issues can be mitigated by utilising a model function that follows the relationship between the distortion beta and  $\Psi$ , smoothing out small jumps and continuing its trend past the largest values of  $\Psi$  obtained in the models. Figure J1 shows an example of the model function in action.

Figure J1. Example of model function fit to the computed result of Psi against the applied and measured distortions. The three parts of the functions can be identified.

The model function,  $f(x)$  as presented in Equation J1, is defined for three discontinuous intervals. Before a value  $x_0$ , the fit returns zero;  $x_0$  corresponds to the lowest beta value in the original data for which  $\Psi$  is no longer zero. Similarly,  $x_3$  determines the lowest beta for which  $\Psi$  is 3; when a value of 3 is not reached in the data, the  $x_3$  identifies the last beta value in the data. For beta ( $x$ ) between  $x_0$  and  $x_3$ , the function returns a power law with regression coefficients  $a_1$ ,  $b_1$ , and  $c_1$ . For  $x$  above  $x_3$ , another power law, with a different slope and shape to accommodate the damage behaviour beyond  $\Psi=3$ , continues the fit; this second power law continues from the same point ( $x_3$ ,

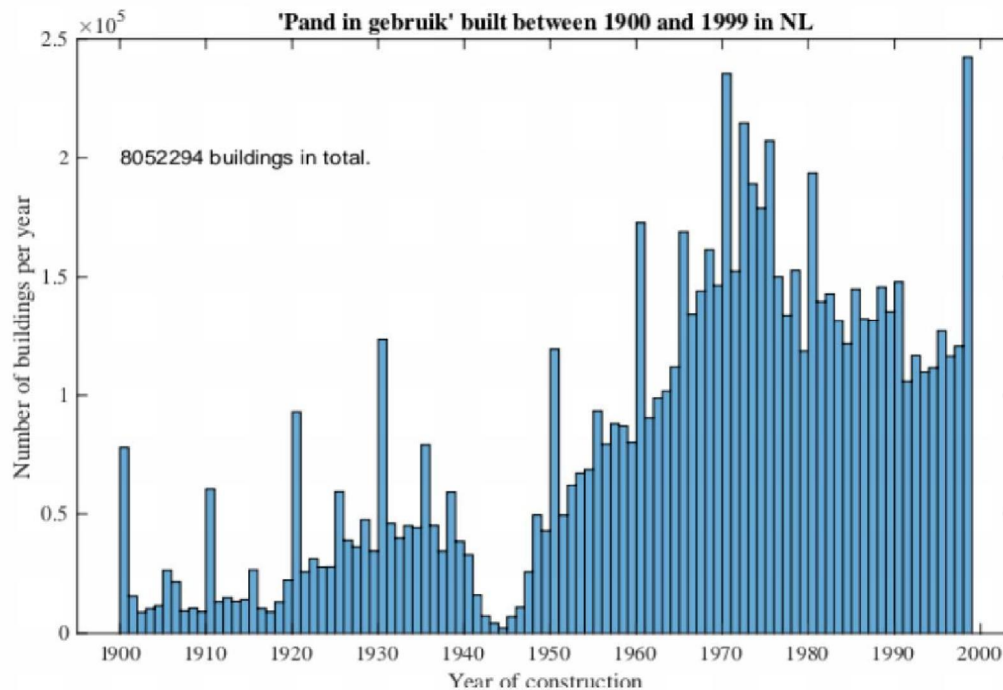
For this study, the entire database has been downloaded and post-processed so as to obtain statistics about the shape of buildings' walls and other building properties, such as slanted roofs, variable roof height, etc. About 45GB of data is present in the Postgres SQL database; from this data, information about 8 million buildings, constructed across the Netherlands between 1900 and 1999, has been extracted. The geometry data encoded with the PostGIS plugin for SQL was converted and imported into Matlab such that building geometry could easily be visualised and processed into statistics at a building population scale. Figure K2. shows a histogram of the buildings according to their construction

year. The influence of historic events, such as WW2, and uncertainty in the data, such as guesses about the construction year being rounded to the nearest decade, are visible in the graph.

Figure K2. Histogram of the year of construction for buildings in the Netherlands available in the BAG 3D database.

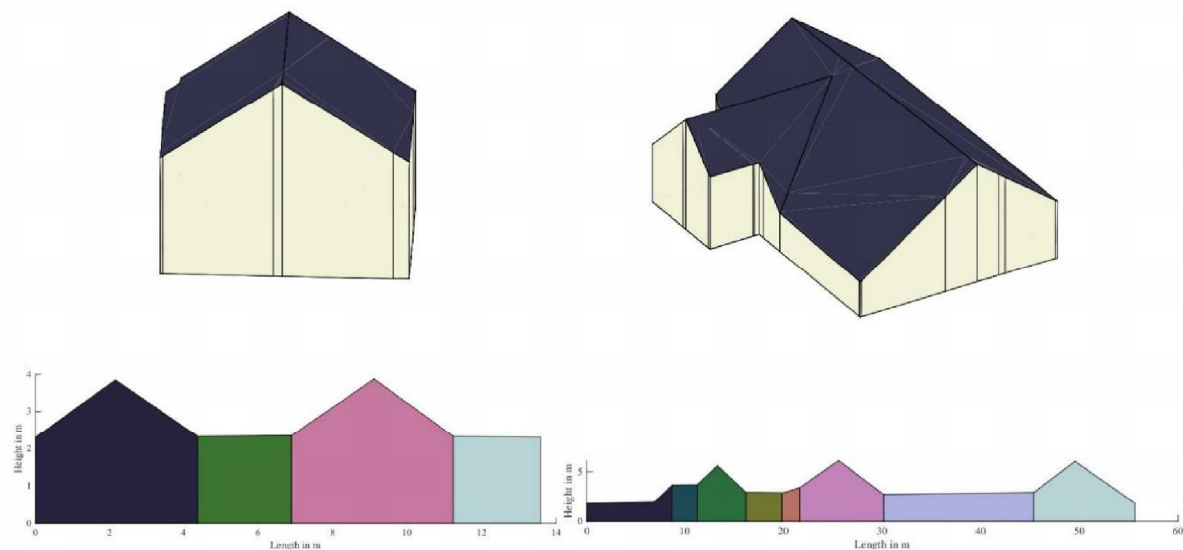
The geometry of the buildings was further processed to identify individual façades in the buildings. A purposely-written program 'unfolds' the 3D geometry into a paper-like net by reconstructing the façades' shape from the roof geometry. Imperfections in the original geometry are restored to produce clearly-defined façades, identifying what could be individual walls. Figure K3 presents two exemplary results from the unfolding program. The algorithm determines thus the wall height and length as well as the overall shape of each wall.

Figure K3. Two examples of the unfolded geometry of two buildings showing the individual walls' length and height.

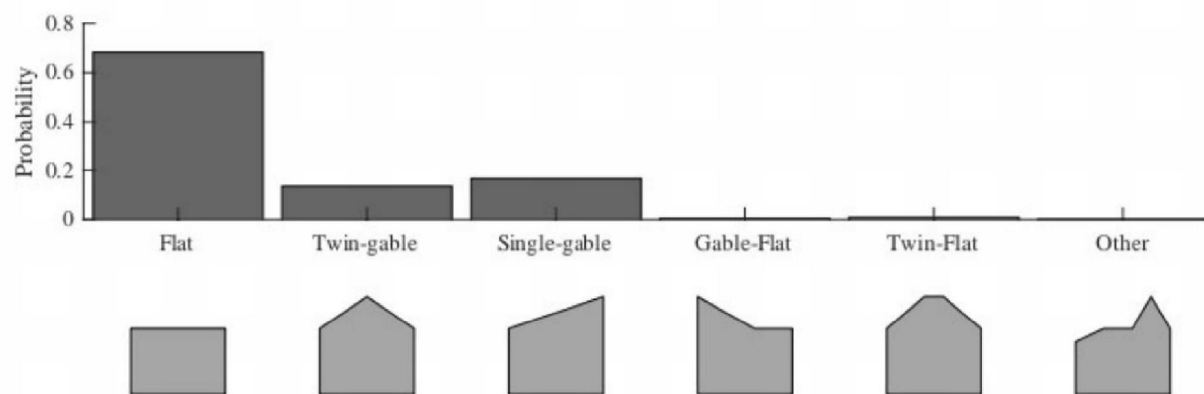
Figure K5. Wall-shape categories automatically assigned for the 847 thousand walls (see Figure K4).

Furthermore, the walls for which the length/height ratio was determined, were also automatically categorised based on their shape as illustrated in Figure K5. Five typical shapes were formulated which encompass most wall geometries. Note that these do not identify the roof shape of the buildings but of the individual walls. Consequently, the most common wall shape is that with a flat upper side which is present in buildings with flat roofs as well as on the sides of buildings with gable roofs. Moreover, two single-gable walls, which may not appear precisely on the same plane or may be separated by a chimney, may be present to form a twin-gable roof.

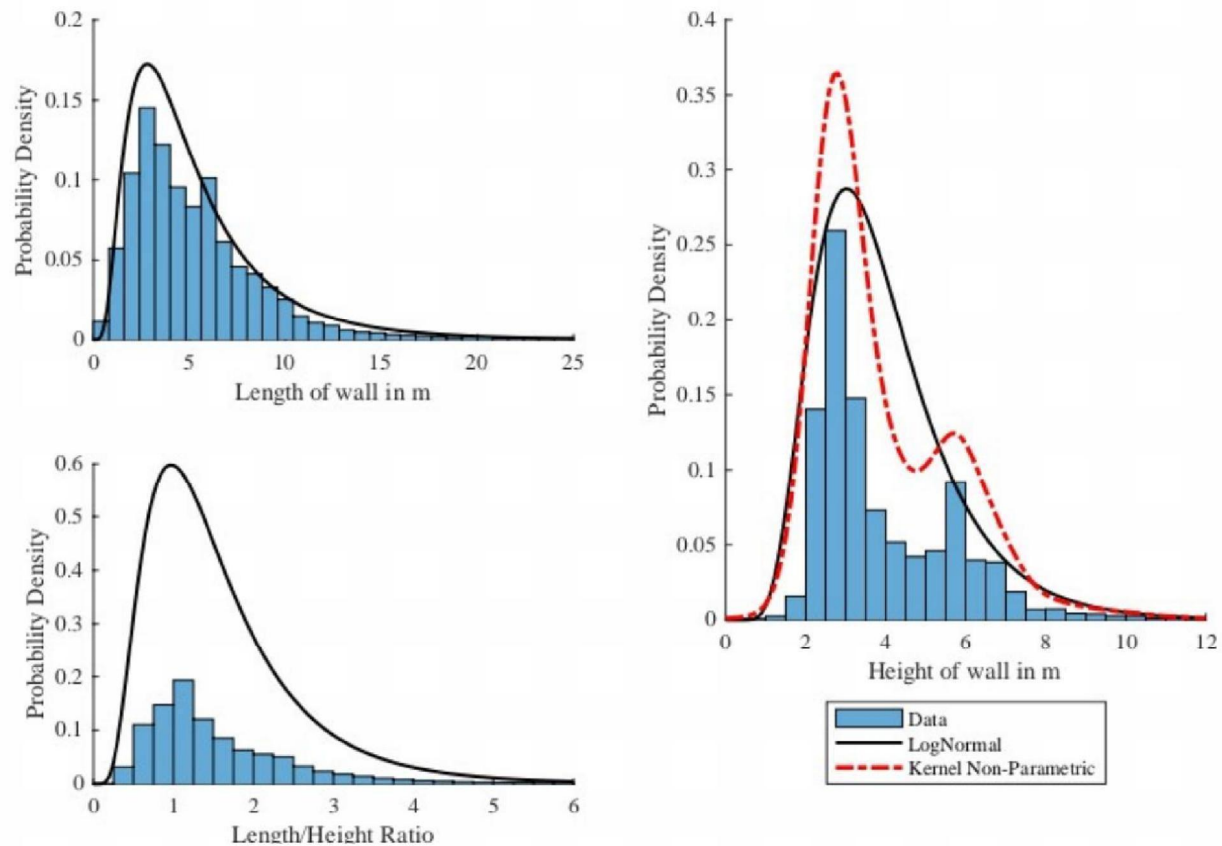
Figure K6. Distribution fit to length and height properties.

The statistics of the geometrical properties obtained from the data can be represented with fitted distributions. The spread of the data matches well with the shape of a lognormal distribution in all cases; however, for representing the height, because of the peak corresponding to walls of two storeys high, either a double lognormal distribution or a non-parametric distribution would better represent the data. In this case, a Kernel distribution can be used to characterise the wall height. The parameters of the lognormal distributions can be found in Table K1.

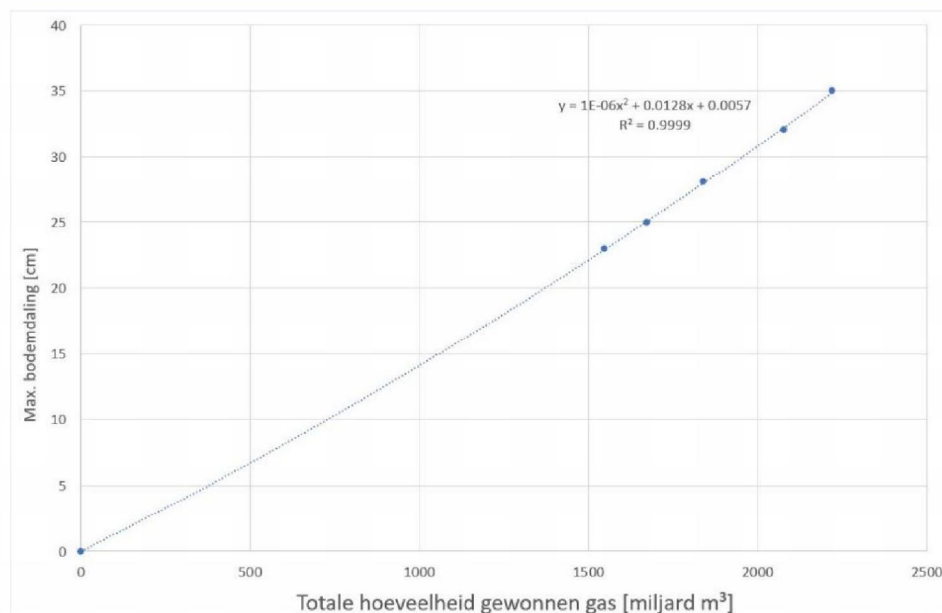
Verondersteld is dat invloedsgebied van het Groningen gasveld min of meer constant blijft (de buitenste contour met 2 cm bodemdaling). Dit beeld wordt ook bevestigd indien alle beschikbare contourlijnen op elkaar worden gelegd. Vervolgens is de totale hoeveelheid onttrokken gas vergeleken met de maximaal opgetreden bodemdaling in de jaren 1998, 2003, 2008, 2013 en 2018. Deze relatie (formule) is weergegeven in onderstaande figuur.

Figuur: Relatie tussen totale hoeveelheid gewonnen gas en opgetreden bodemdaling

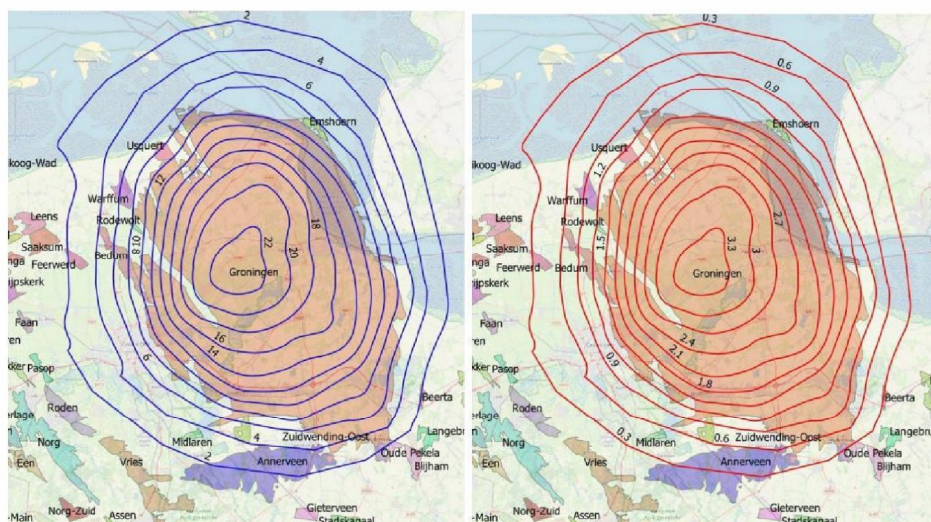
In de volgende figuur zijn de aldus bepaalde opgeschoonde contourlijnen van 1973 weergegeven. Voor 1973 bedraagt de schalingsfactor  $x_{0,15}$ . De contourlijn met een bodemdaling van 22 cm in 1998 bedraagt  $22 \times 0,15 = 3,3$  cm in 1973.

Figur: Contourlijnen 1998 (links); contourlijnen 1973 (rechts) = 1998 x 0,15

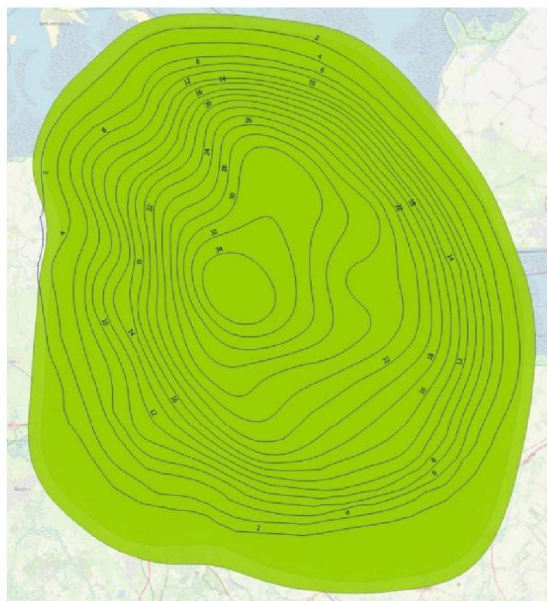
Door TNO is de 1 cm bodemdalingscontourlijn (bodemdaling op 1 oktober 2021) aangeleverd voor het Groningen gasveld. In onderstaande figuren wordt deze 1 cm bodemdalingscontourlijn vergeleken met de contourlijnen in 2018, 2003 en 1998. Hierbij is het gebied binnen de 1 cm bodemdalingscontour in groen weergegeven en de opgeschoonde contourlijnen in blauw.

*Figuur: Gebied binnen 1 cm bodemdalingscontourlijn 10-2021 TNO (groen) vs. opgeschoonde contourlijnen 2018 (blauw)*

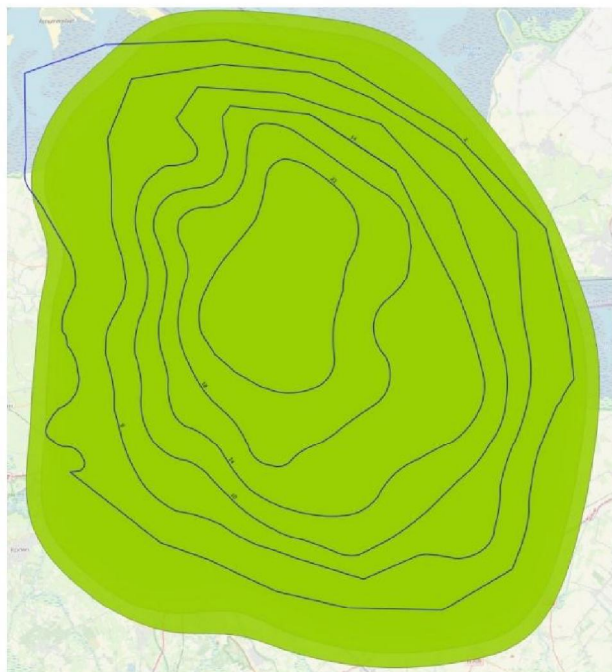
*Figuur: Gebied binnen 1 cm bodemdalingscontourlijn 10-2021 TNO (groen) vs. opgeschoonde contourlijnen 2003 (blauw)*

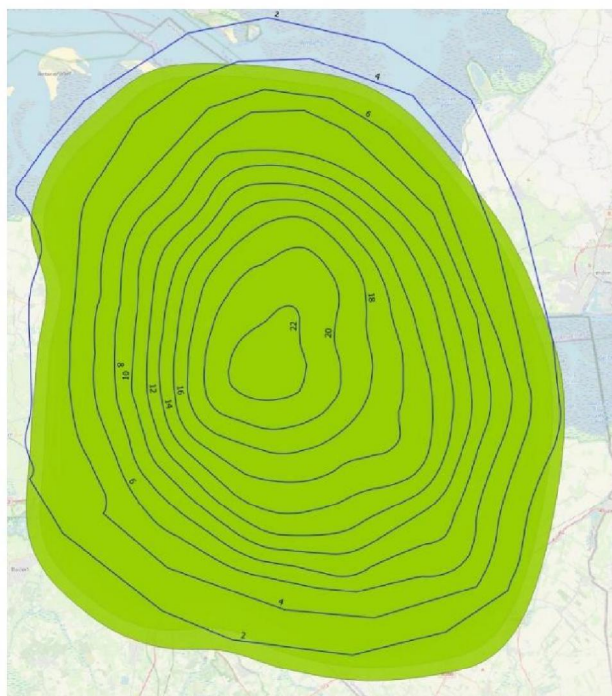
*Figuur: Gebied binnen 1 cm bodemdalingscontourlijn 10-2021 TNO (groen) vs. opgeschoonde contourlijnen 1998 (blauw)*
